試驗報告 TEST REPORT

TEST REPORT NO. : N1205030-T01

Customer :		
	NovaVision, LLC 524 East Woodland Circle Bowling Green, Ohio 43402 USA	
Subject :	Freight containers Mechanical seals classification Testing	
Name of Article :	CABLE SEALS	
Type :		
	NovaVision, LLC	MS-CS3.5X
Received Date :	2024/12/05	
Test Dates :	2024/12/30~2025/01/06	
Date Issued :	2025/01/06

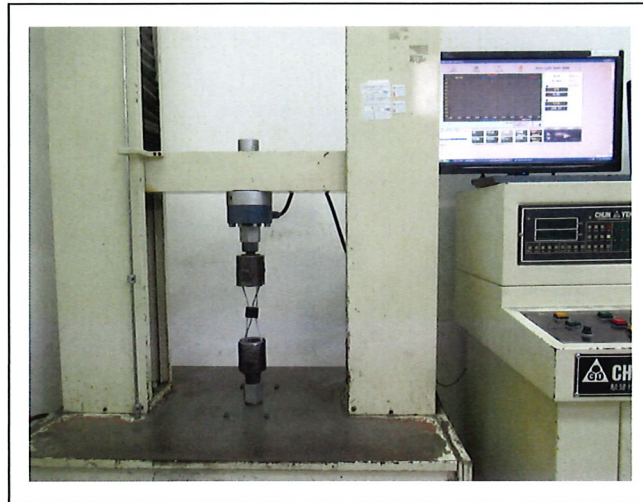
Testing Instrument : Universal Testing Machine (No.TG0103)

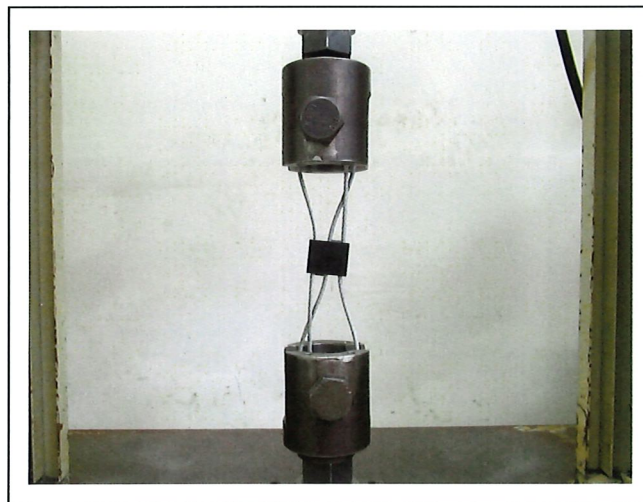
Tensile Set up

The seal was gripped in a tensile machine and a pull force applied.

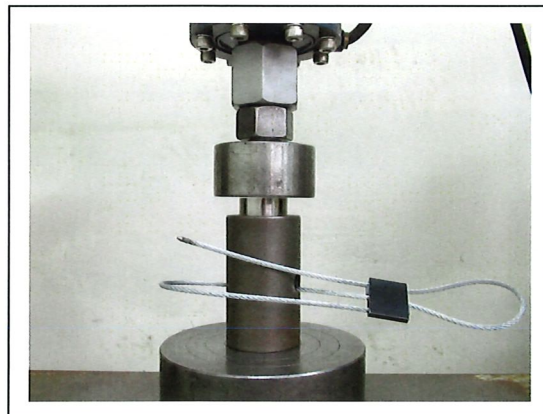
Shear Set up

The seal was fixed in a universal testing machine to withstand cutting with shearing blades and a compressive load applied slowly until the seal is severed.

SAFETY PRECAUTIONS - Do not exceed a shear force greater than 8900N(2001lbf). If the specimen has not failed at that force, halt the test and unload the test equipment. Record a shear force of 8896N (2000 lbf). Sudden and violent rupture of the test specimen can endanger personnel, equipment and property.

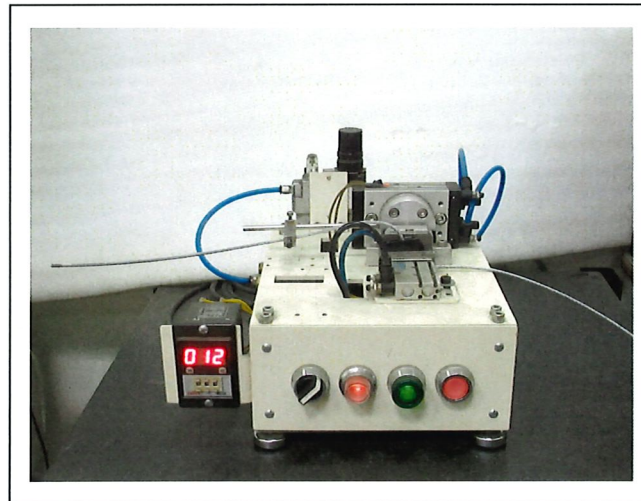
Bend Set up

Fix the locking end and flex the material adjacent to this fixed end repeatedly through an arc of 180° until failure

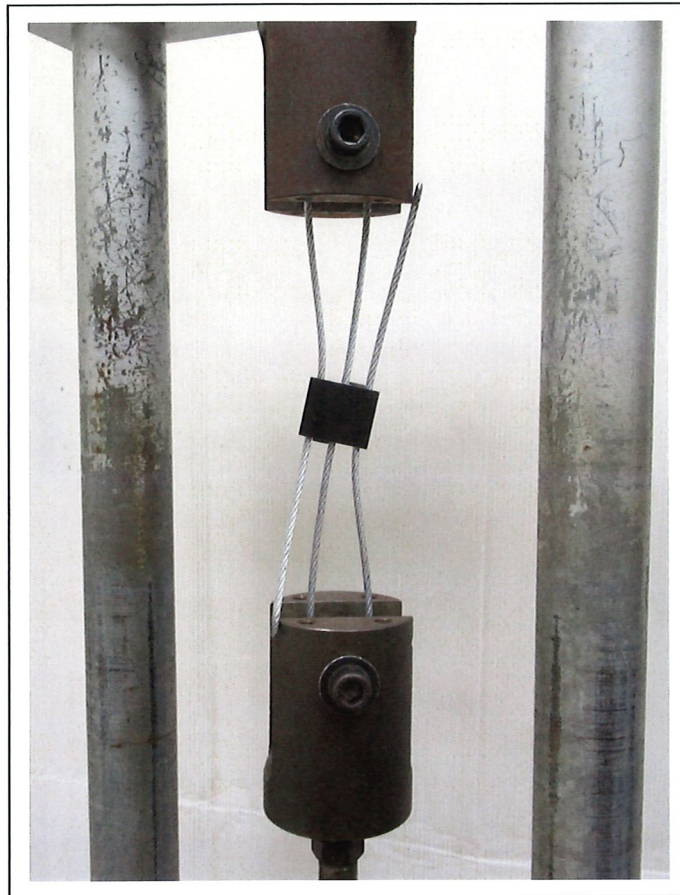
Impact Set up

The impact load is applied at the locking mechanism of the seal in the direction opposite the direction used in locking the seal.

The impact test is performed at 18 degrees C and minus 27 degrees C of temperature.

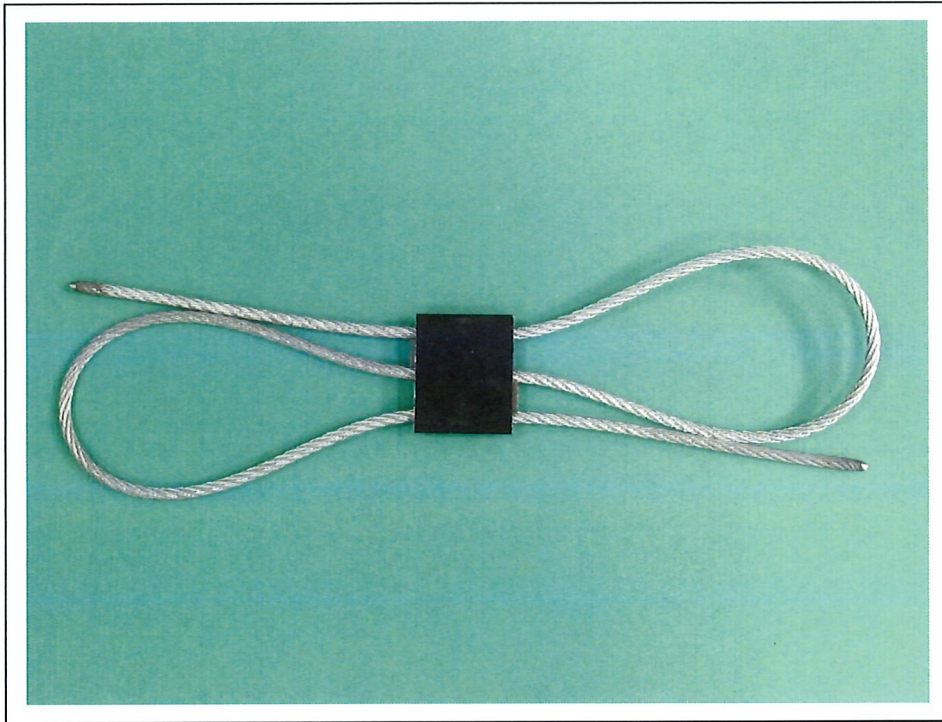
CABLE SEALS

Type		
	NovaVision, LLC	MS-CS3.5X
