試驗報告 TEST REPORT

Test Report No. : O0923130-T01

Customer :	ZHEJIANG OUFU CONTAINER SEAL CO., LTD. Building 25, NO.1336 HANGFU ROAD, CHONGFU TOWN, TONGXIANG CITY, JIAXING CITY, ZHEJIANG PROVINCE, CHINA 314511 NovaVision, LLC 524 EAST WOODLAND CIRCLE BOWLING GREEN, OH 43402 USA	
Subject :	Freight containers Mechanical seals classification Testing	
Name of Article :	BOLT SEALS	
Type :	Zhejiang Oufu	OF-B10
	NovaVision, LLC	MS-B10
Received Date :	2025/09/23	
Test Dates :	2025/09/23~2025/09/30	
Date Issued :	2025/09/30

Customer :	ZHEJIANG OUFU CONTAINER SEAL CO., LTD. Building 25, NO.1336 HANGFU ROAD, CHONGFU TOWN, TONGXIANG CITY, JIAXING CITY, ZHEJIANG PROVINCE, CHINA 314511	
	NovaVision, LLC 524 EAST WOODLAND CIRCLE BOWLING GREEN, OH 43402 USA	
Name of Article :	BOLT SEALS	
Type :	Zhejiang Oufu	OF-B10
	NovaVision, LLC	MS-B10
Serial No. : 01~ 26		
Quantity Tested : 26		
Inspection Reference : ISO 17712:2013(E)

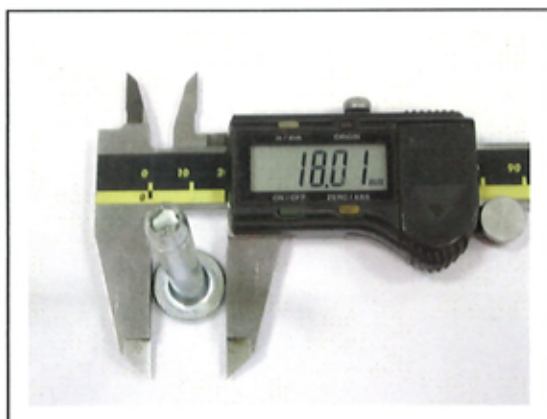
Specimen No.	Measurement (mm)		Pass/Fail
26	Pin Head	18.01	Pass
	Lock Body	18.12	Pass

The minimum diameter (or minimum widest cross-dimension) for the metal components of a bolt seal shall be 18 mm.

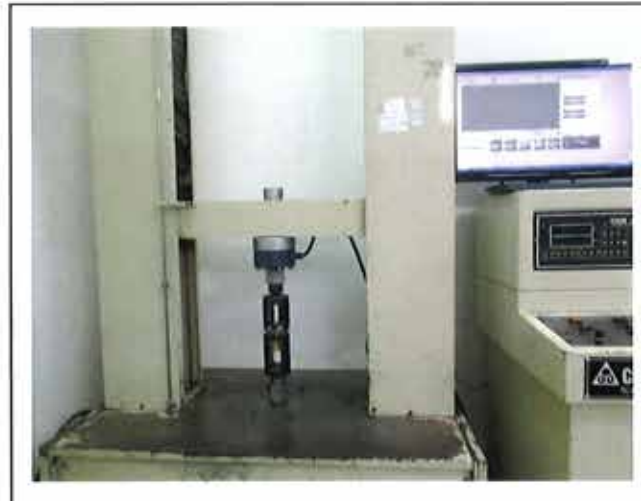
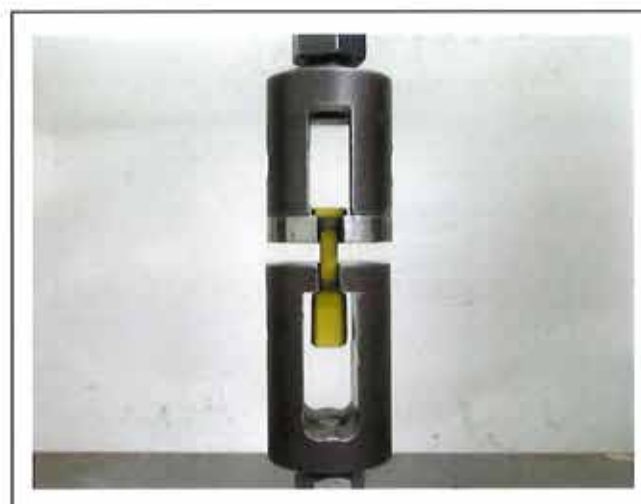
Tensile Set up

The seal was gripped in a tensile machine and a pull force applied.

Specimen No.	Requirement Load to failure	Result kN	Seal classification
01	10.0 kN : High security seal 2.27 kN : Security seal < 2.27 kN : Indicative seal	22.6	High security seal (H)
02		26.0	High security seal (H)
03		24.9	High security seal (H)
04		25.1	High security seal (H)
05		23.9	High security seal (H)

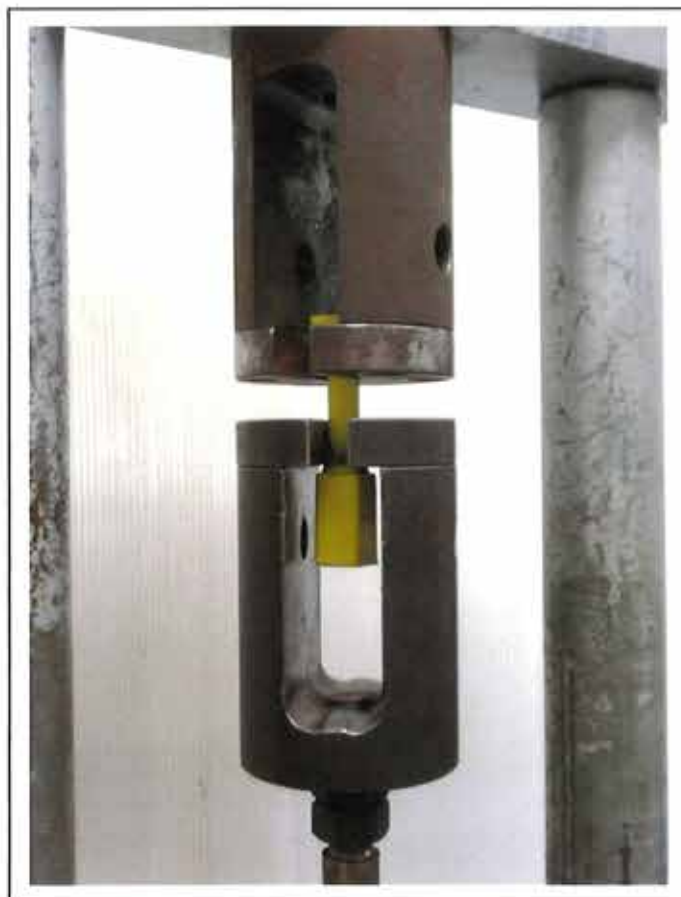
Impact Set up

The impact test is performed at 18 degrees Celsius and minus 27 degrees Celsius of temperature.

The impact load is applied at the locking mechanism of the seal in the direction opposite the direction used in locking the seal.

Impact Test at 18±3°C					
Specimen No.	Requirement	Result Joule			Seal classification
		13.56	27.12	40.68	
16	40.68J : High security seal 27.12J : Security seal <27.12J : Indicative seal 5 impacts at each load	Pass	Pass	Pass	High security seal (H)
17		Pass	Pass	Pass	High security seal (H)
18		Pass	Pass	Pass	High security seal (H)
19		Pass	Pass	Pass	High security seal (H)
20		Pass	Pass	Pass	High security seal (H)

Impact Test at -27±3°C					
Specimen No.	Requirement	Result Joule			Seal classification
		13.56	27.12	40.68	
21	40.68J : High security seal 27.12J : Security seal <27.12J : Indicative seal 5 impacts at each load	Pass	Pass	Pass	High security seal (H)
22		Pass	Pass	Pass	High security seal (H)
23		Pass	Pass	Pass	High security seal (H)
24		Pass	Pass	Pass	High security seal (H)
25		Pass	Pass	Pass	High security seal (H)

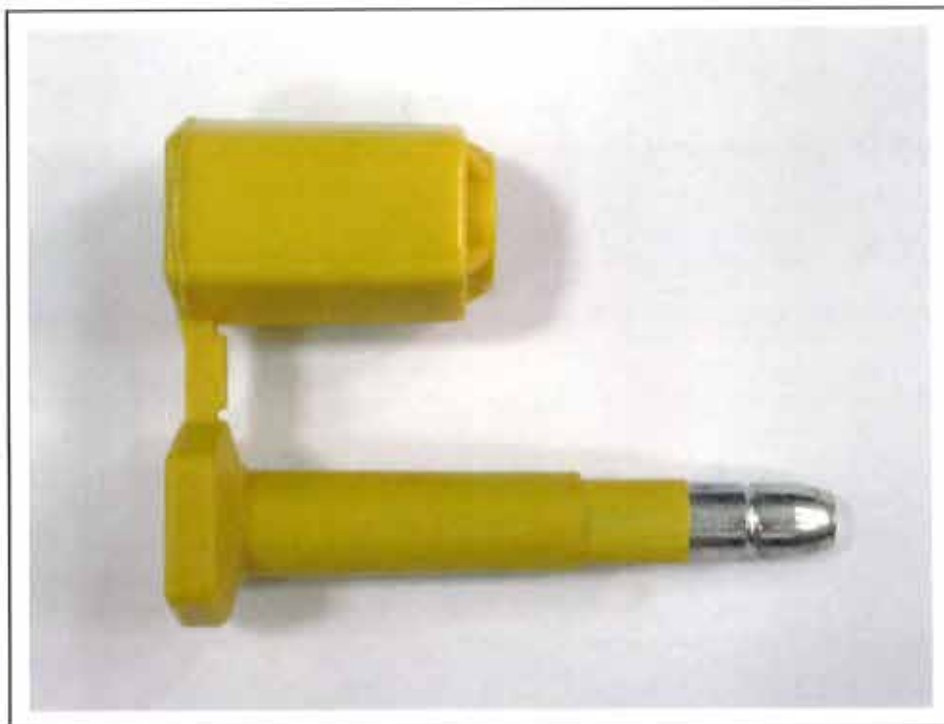
Name of Article : BOLT SEALS

Type	Zhejiang Oufu	OF-B10
	NovaVision, LLC	MS-B10
