試驗報告 TEST REPORT

Test Report No. : N0422126-T01

Customer :	ZHEJIANG OUFU CONTAINER SEAL CO., LTD. Building 25, NO.1336 HANGFU ROAD, CHONGFU TOWN, TONGXIANG CITY, JIAXING CITY, ZHEJIANG PROVINCE, CHINA 314511	
	NovaVision, LLC 524 East Woodland Circle Bowling Green, Ohio 43402 USA	
Name of Article :	BOLT SEALS	
Type :	Zhejiang Oufu	OF-B08
	NovaVision, LLC	MS-B8
Serial No. :	01~ 26	
Quantity Tested :	26	
Inspection Reference :	ISO 17712:2013(E)

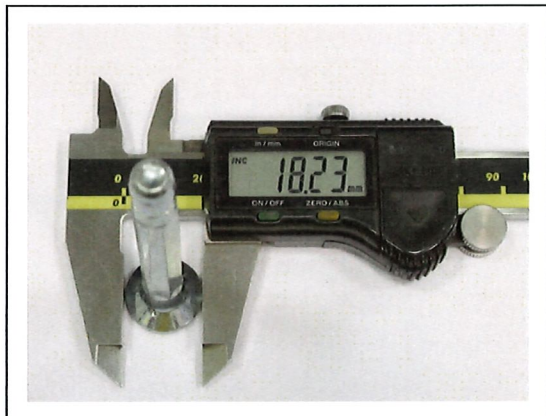
Specimen No.	Measurement (mm)		Pass/Fail
26	Pin Head	18.23	Pass
	Lock Body	18.02	Pass

The minimum diameter (or minimum widest cross-dimension) for the metal components of a bolt seal shall be 18 mm.

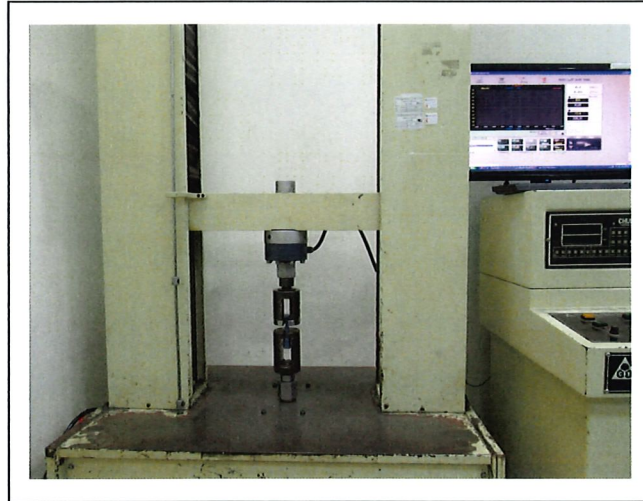
Testing Instrument : Universal Testing Machine (No.TG0103)

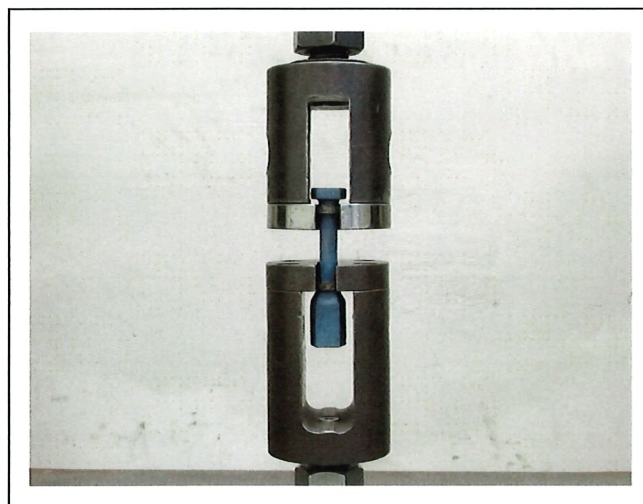
Tensile Set up

The seal was gripped in a tensile machine and a pull force applied.

Specimen No.	Requirement Load to failure	Result kN	Seal classification
01	10.0 kN : High security seal 2.27 kN : Security seal < 2.27 kN : Indicative seal	18.4	High security seal (H)
02		20.7	High security seal (H)
03		18.8	High security seal (H)
04		21.6	High security seal (H)
05		26.7	High security seal (H)

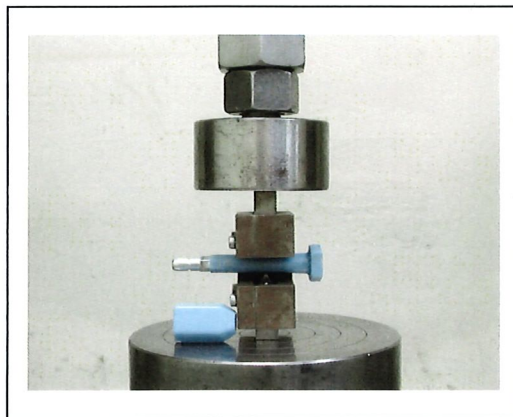
Shear Set up

The seal was fixed in a universal testing machine to withstand cutting with shearing blades and a compressive load applied slowly until the seal is severed.

Specimen No.	Requirement Load to failure	Result kN	Seal classification
06	3.336 kN : High security seal 2.224 kN : Security seal <2.224 kN : Indicative seal	8.896	High security seal (H)
07		8.896	High security seal (H)
08		8.896	High security seal (H)
09		8.896	High security seal (H)
10		8.896	High security seal (H)

SAFETY PRECAUTIONS - Do not exceed a shear force greater than 8900N(2001lbf). If the specimen has not failed at that force, halt the test and unload the test equipment. Record a shear force of 8896N (2000 lbf). Sudden and violent rupture of the test specimen can endanger personnel, equipment and property.

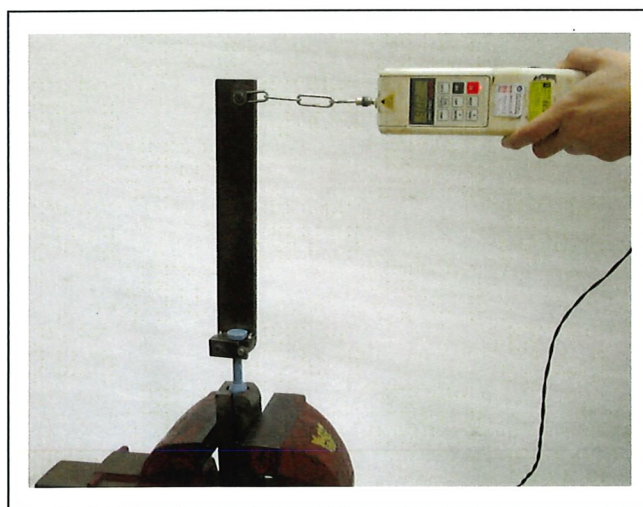
Bend Set up

Fix the locking end on the universal testing machine in a horizontal position.

Apply a load on the remaining portion of the seal at a distance (the moment arm) above the fixed end so as to bend the seal 90 degrees.

Specimen No.	Requirement Bending moment to failure	Result N·m	Seal classification
11	50 N·m : High security seal 22 N·m : Security seal < 22 N·m : Indicative seal	69.6	High security seal (H)
12		72.8	High security seal (H)
13		69.7	High security seal (H)
14		67.2	High security seal (H)
15		71.8	High security seal (H)

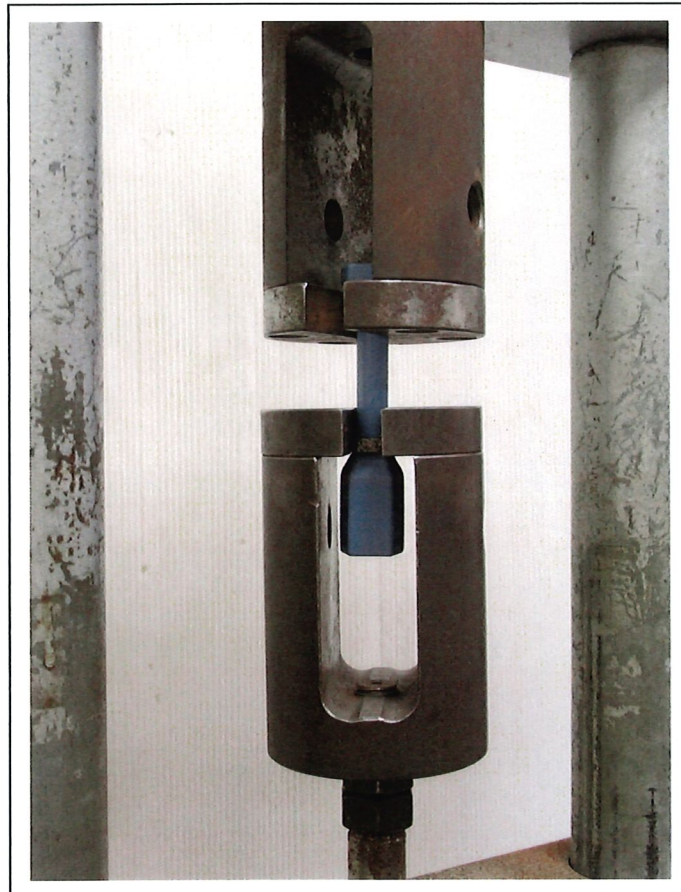
Impact Set up

The impact test is performed at 18 degrees C and minus 27 degrees C of temperature.

The impact load is applied at the locking mechanism of the seal in the direction opposite the direction used in locking the seal.

Impact Test at 18±3°C					
Specimen No.	Requirement	Result Joule			Seal classification
		13.56	27.12	40.68	
16	40.68J : High security seal 27.12J : Security seal <27.12J : Indicative seal 5 impacts at each load	Pass	Pass	Pass	High security seal (H)
17		Pass	Pass	Pass	High security seal (H)
18		Pass	Pass	Pass	High security seal (H)
19		Pass	Pass	Pass	High security seal (H)
20		Pass	Pass	Pass	High security seal (H)

Impact Test at -27±3°C					
Specimen No.	Requirement	Result Joule			Seal classification
		13.56	27.12	40.68	
21	40.68J : High security seal 27.12J : Security seal <27.12J : Indicative seal 5 impacts at each load	Pass	Pass	Pass	High security seal (H)
22		Pass	Pass	Pass	High security seal (H)
23		Pass	Pass	Pass	High security seal (H)
24		Pass	Pass	Pass	High security seal (H)
25		Pass	Pass	Pass	High security seal (H)

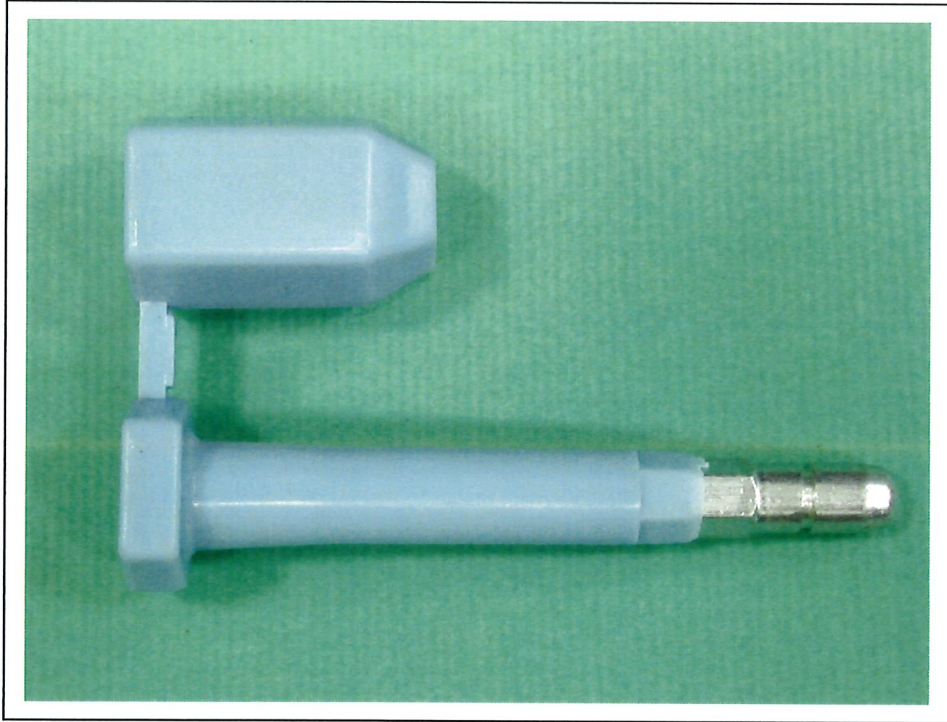
BOLT SEALS

Type	Zhejiang Oufu	OF-B08
	NovaVision, LLC	MS-B8
